mcHF Hardware modifications as of October 28, 2014 as compiled by KA7OEI for Revision 0.3 boards

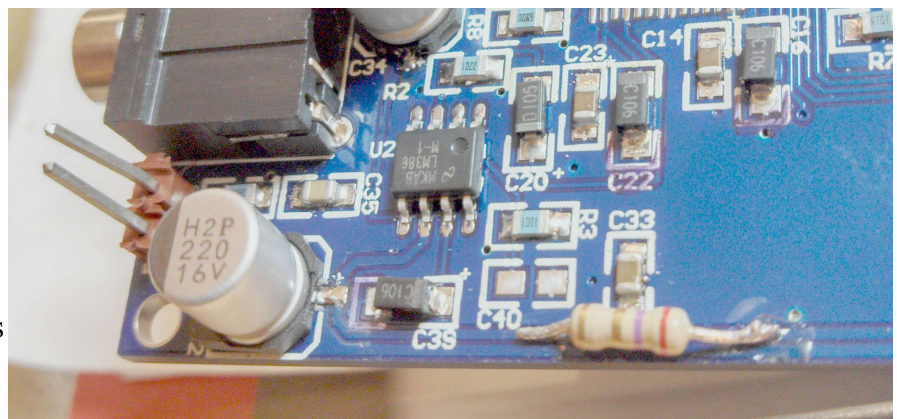
This is an important modification that fixes one source of oscillation at high volume levels.

This modification prevents audio from appearing on the 8 volt line which, in turn, causes audio to appear on the ground busses and other power supplies in the radio which can cause feedback, particularly at high volume levels with wider audio filters.

The 4.7 ohm resistor added to the UI_8V line feeding U2, the audio amplifier.

The insertion of a 4.7 ohm, 1/2 watt resistor in series (or two 10 ohm 1/8 watt resistors in parallel) with the +8 volt line, near the LM386 audio amplifier.

I'd originally suggested a 2.7 ohm resistor, but I later found 4.7 ohms to be better, as Chris pointed out.

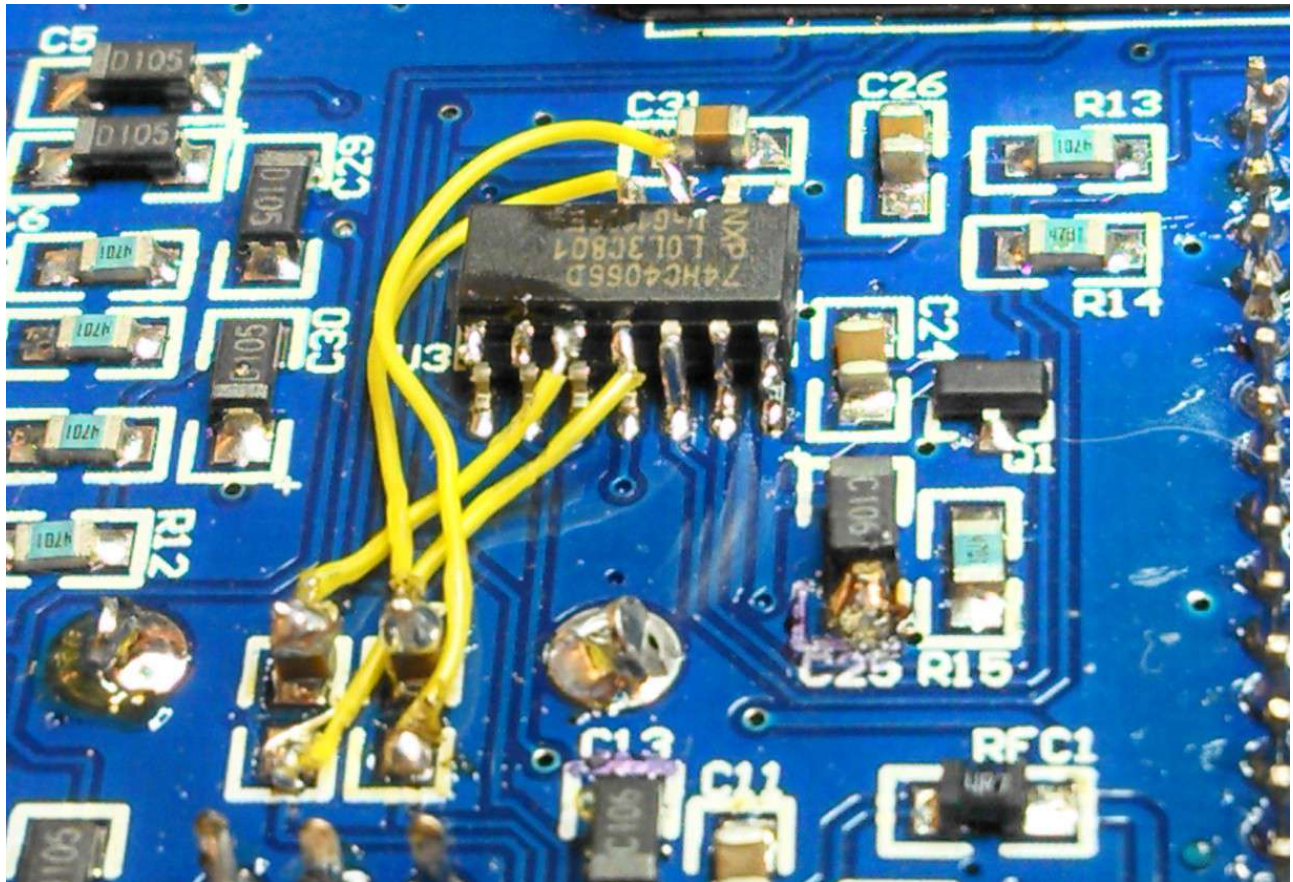
The "U3a" modification, piggybacking another 74HC4066 atop U3 to prevent feedback into the receiver.

This modification is relatively simple and it seems to be effective in solving this particular feedback problem: This 'mod, in addition to the installation of a 4.7 ohm resistor in the 8 volt supply line for U2, the audio amplifier (see message #144) has caused my receiver (board revision 0.3) to be (almost) completely stable on all bands at all volume levels.

This modification prevents “breakthrough” of the TX QSD mixer (U17) caused by the fact that the Codec's DA is shared both for RX audio and TX modulation. Because the audio drivers for the TX modulator (U20-U23) are powered from 8 volts it is possible for high RX level audio to violate logic levels at U17, turning it “on” on voltage peaks: The result of this is highly-distorted, on-frequency noise/feedback.

The installation of "U3a", a 74HC4066 switch, piggybacked atop U3 - a pretty easy mod, once you have soldered the rest of the board. This fixes a source of distortion/oscillation in the receiver, particularly at high volume levels and on high bands. The chip for "U3a" is the same type as U3.

Take a 74HC4066 chip, of the same type and package as U3 and piggyback it atop U3 (on the UI board) and use its power supply and control signals. This chip will now be able to turn on/off the TX I and Q signals with a bit of fairly simple rewiring. Let us call this new chip "U3a"

The procedure is approximately thus:

- On the new 74HC4066, U3a, bend pins 5, 6, 7, 12, 13 and 14 straight down using a VERY FINE pair of needle nose pliers or tweezers. Bending these leads down will cause them to be

just long enough to allow them to be overlaid atop U3 and connected to it.

- Bend pins 1, 2, 3, 4, 8, 9, 10 and 11 of U3a straight out using a the same pair of very fine needle nose pliers or tweezers.
- Set this chip atop U3, making sure to align pin 1 with pin 1.

- Using a VERY FINE tip, solder pin 14 of U3a to pin 14 of U3.
- Align pin 7 of U3a to U3 and solder.
- Now solder pins 5, 6, 12 and 13 of U3a to U3.
- Remove capacitors C7 and C8 and stand them on end, attaching them to the pad closest to U3, the upper pad. This will leave the lower pads of C7 and C8 empty. You can turn C7 and C8 around, the “open” end facing U3 rather than mounting them on end, if you prefer.

- Using fine-gauge wire such as #30 AWG wire-wrap wire, run leads to sections 1 and 4 of U3a. For example, the wires connecting across the connection of C8 would go to pins 1 and 2 of U3a and the connection of C7 would go to pins 10 and 11 of U3a. Which wire goes to which side of the switch does not matter, nor does which connection goes to which switch.

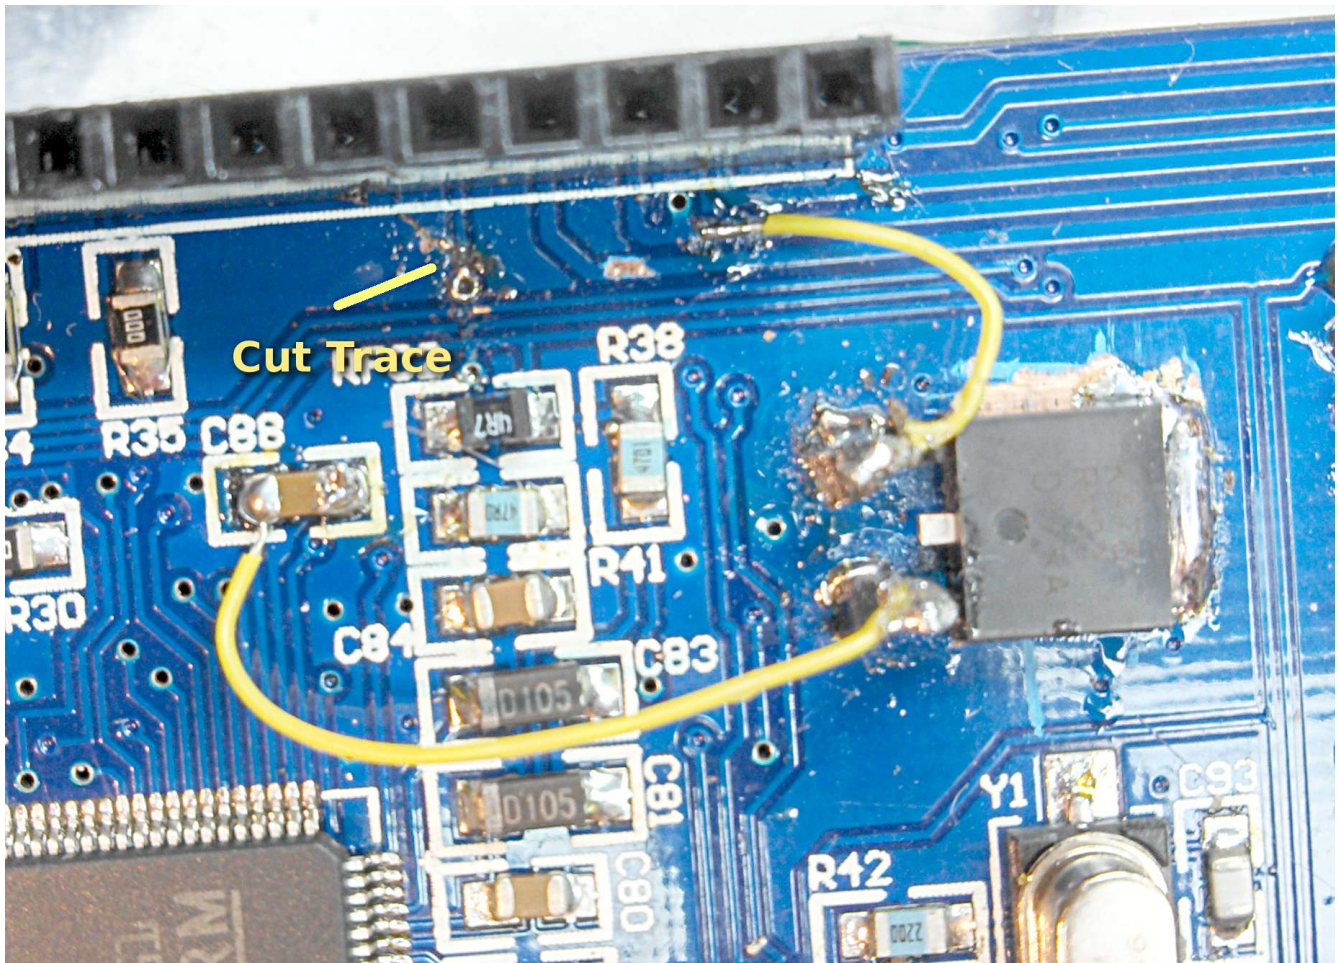
The recommended installation of another 3.3 volt regulator on the UI board for the MCU: This mod is actually easier than the "U3a" mod and uses the same type of parts as those that you'd already have gotten (e.g. another 3.3 volt regulator and two more 10uF capacitors.) This reduces one source of low-level noise getting into the receiver due to the MCU's modulation of current on the 3.3 volt line shared with low-level audio circuitry.

*The added 3.3 volt regulator to deliver an isolated power supply to U4a, the MCU. This reduces a noise source that can get into low-level RF and audio stages. The trace is cut just **above** the via.*

There are still some MCU-related noises on the 8, 5 and 3.3 volt power supply lines that need to be addressed, but this reduces the lions share of it.

The trace to isolate the 3.3 volt supply feeding the MCU is indicated on the picture and it should be cut **just above** the via that goes through to the other side of the board. The 3.3 volt output from the added regulator is shown connected to the left-hand side of C88, below.

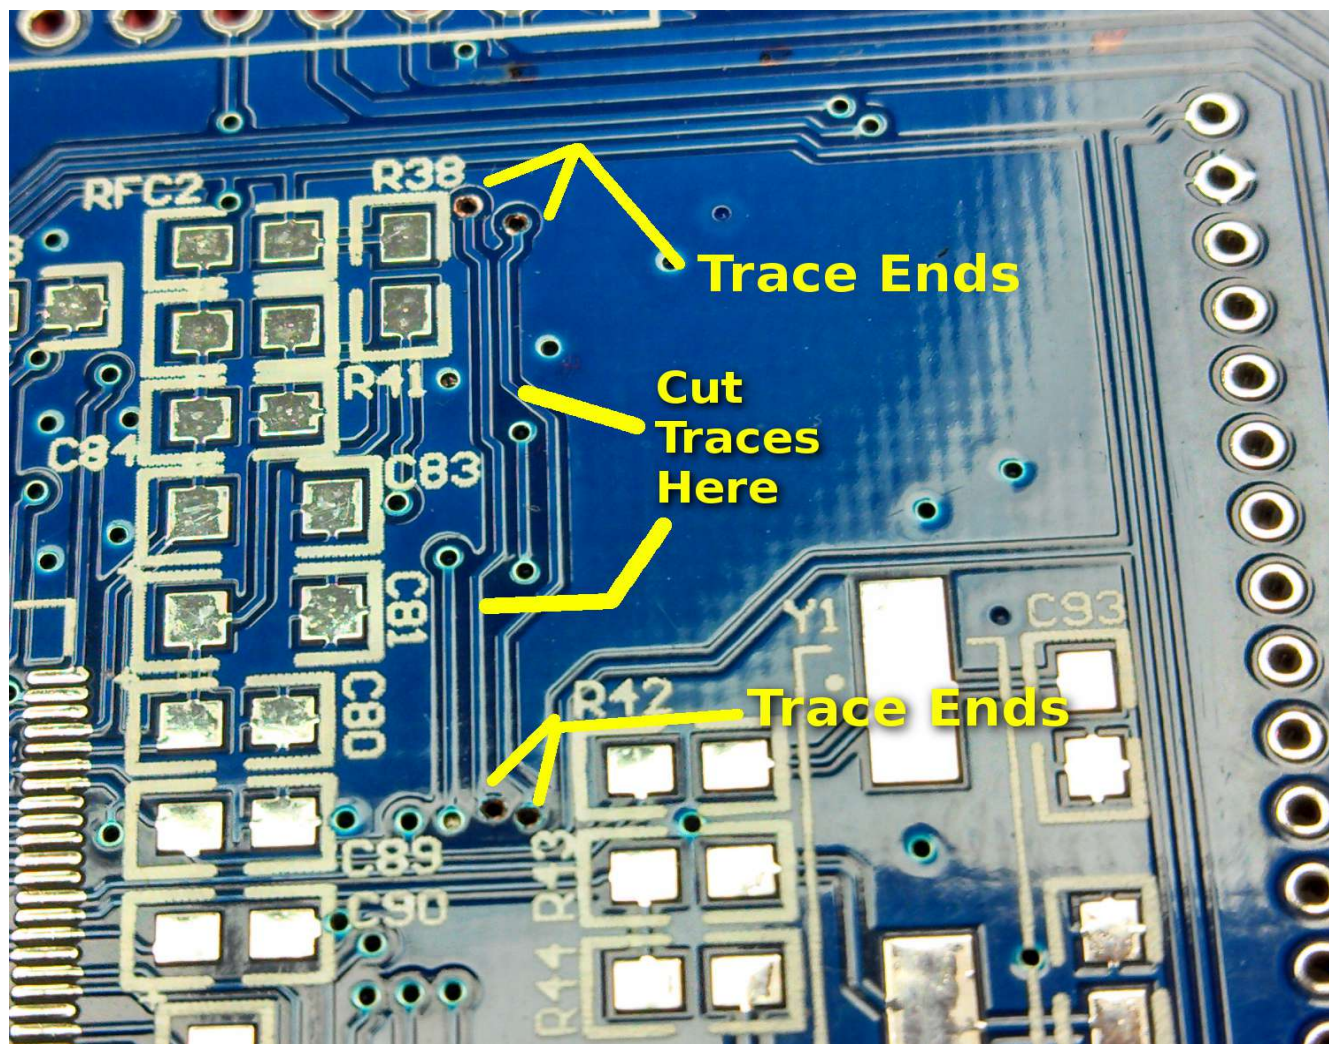
If the above modifications are made, with no antenna connected – or even with an antenna connected when listening on higher bands (especially 20 meters and above) a fairly strong “tick” may be heard every second. This is due to the polling of the onboard temperature sensor and the fact that the “fall” time of the on the I2C line from the MCU is extremely fast and rich with harmonic energy. This problem can be easily “fixed” with the addition of resistors on the UI board in series with the SCL and SDA lines which effectively reduce the slew rate of these lines, quashing the RF energy.

This picture shows the location of the traces and where the cuts should be made. This is found to the right and above U4a, the MCU. A picture of a “bare” board is used for clarity.

To identify the traces into which the resistors are to be installed, refer to the picture below:

A reasonable value of resistor to install is 470 ohms and the installed components may be seen in the picture.

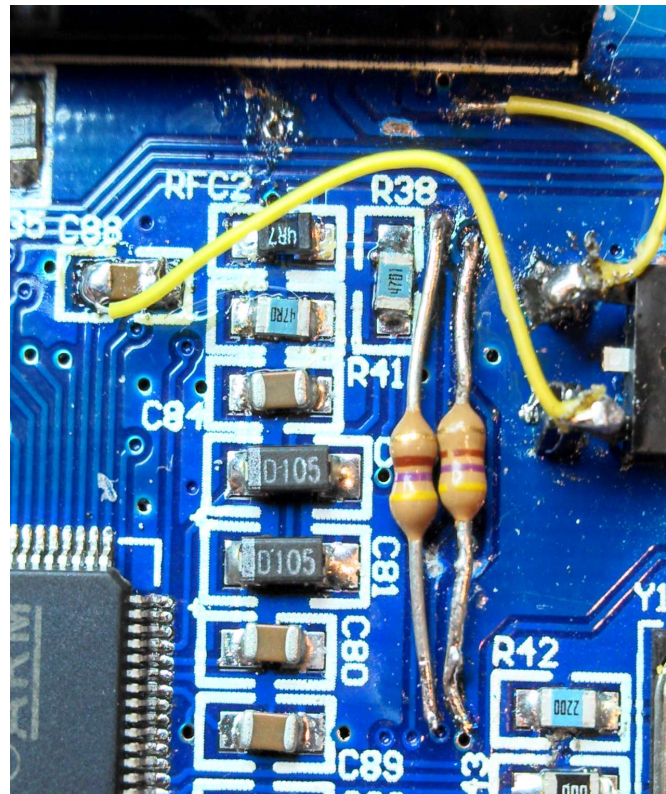
In the picture can be seen the two added 470 ohm resistors. As you can see, I used leaded 1/8 watt resistors, but surface mount resistors can be used, instead if that is your preference. (The 3.3 volt regulator used for the MCU – see the modification earlier in this document – can be partially seen.)

This modification appears to be *completely* effective in removing the “tick” noise from the higher bands and does not appear to compromise the operation of the I2C data stream in any way.

The added 470 ohm resistors in series with the SCL and SDA lines. Note that this picture also shows the added 3.3 volt MCU regulator mentioned above. 1/8 watt, leaded resistors are used, but surface mount resistors could be used, if desired.

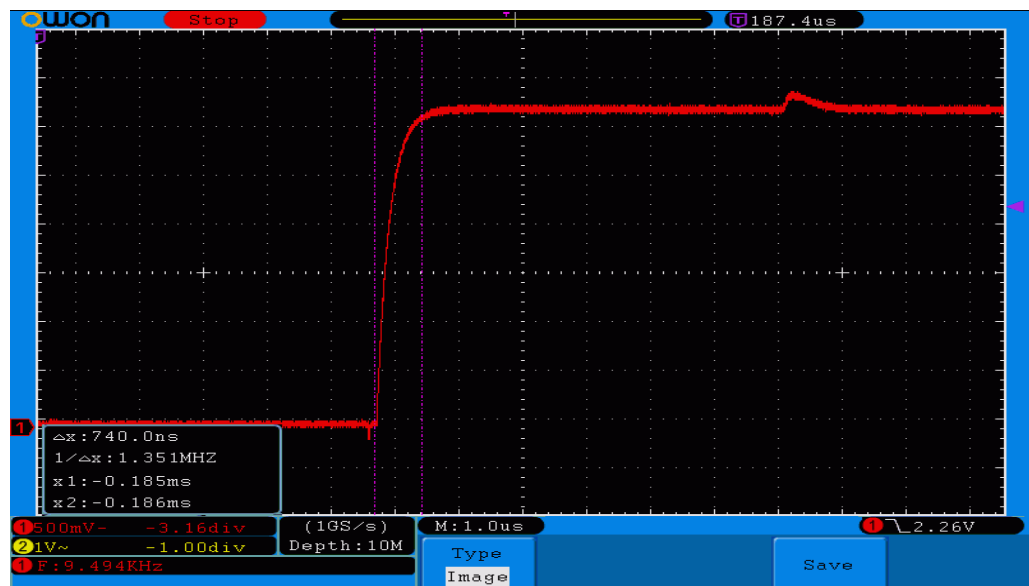
To verify the integrity of the I2C data stream – which is shared with the Si570 frequency synthesizer – I monitored the data stream with a digital storage oscilloscope and measured the worst-case slew rate – which was actually the risetime - the result being noted below.

As can be seen, the risetime is less than 740 ns at the 10%-90% points which is a fraction of the I2C clocking rate, well within the time at which the edge of the clock into which the data is strobed in by the peripheral.

Of the rise and fall times on the I2C, the slowest slew rate was the rise time shown in this digital oscilloscope capture, which is well within the acceptable time for the clocking rate!
